BRITISH MOUNTAINEERING COUNCIL

TECHNICAL COMMITTEE MEMORANDUM TCM 12/09

Wild Country Technical Friends stem cable failures Incident Ref. 07/12/LHEI

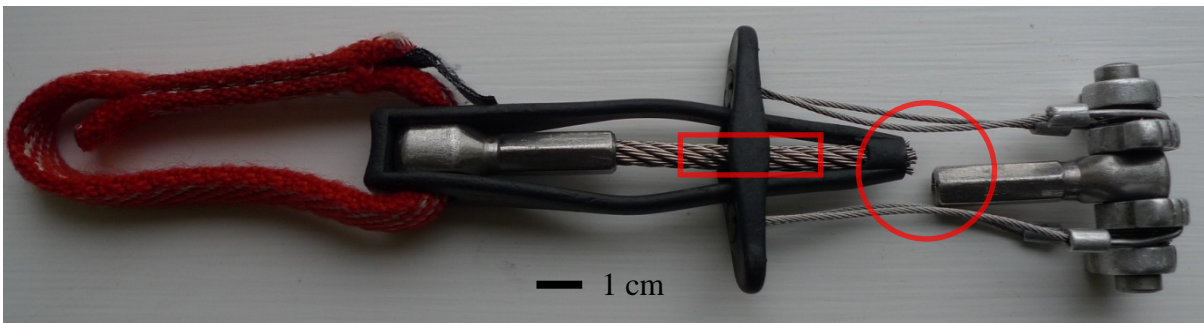
Figure 1: Red 0.5, location of failure circled, location of figure 2 marked by rectangle

The stem cable on each cam has failed where the cable connects to the solid head of the stem (Figures 1 and 4). Viewing the cable side of the broken wires end on (Figure 7), the wires in each of the cables are located fairly centrally. The axial location of the breaking point in each wire, in both cams, is within the solid stem and embedded at a distance of between 0-2mm from the open end of the solid stem (Figure 8). The more central wires tend to have broken slightly higher (that is, towards sling end of the cam), while the outer wires are broken at a point deeper within the solid stem, possibly due to the stem acting as a stress concentration on the wires.

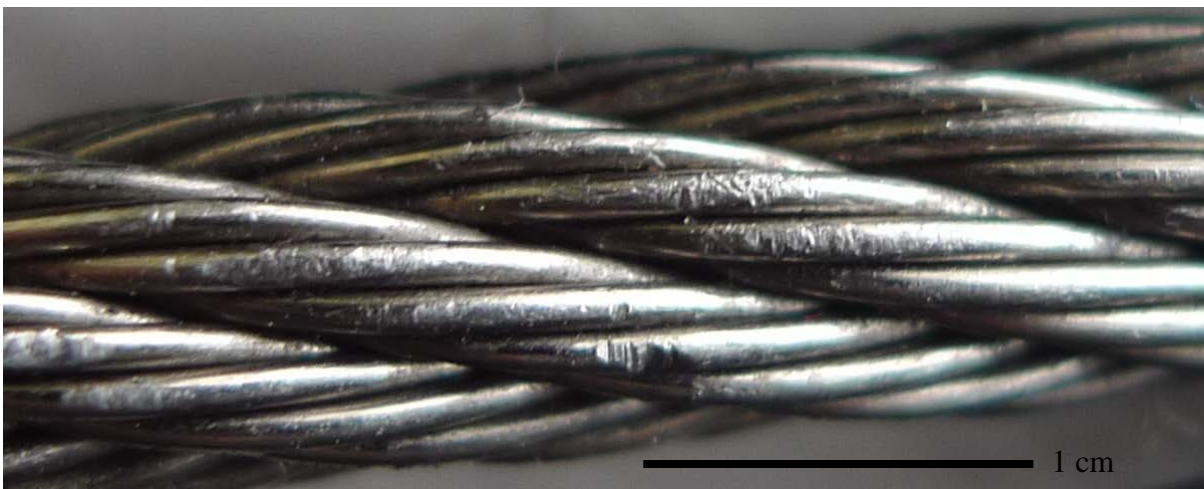
Figure 2: Red 0.5 cable abrasion

Generally speaking, both cams show very high wear and have clearly been heavily used. There is significant abrasion on the stem cables and plastic cable sheaths. The most likely cause of this would seem to be the cables and sheaths rubbing against rock surfaces when the cams were placed in use. In order for the cable to abrade while the cam is anchored in place, the cable must bend. The significant abrasion on the cables would therefore seem to suggest that the cables have been bent many times. There are many possible causes of cable bending in use; for example during placement (i.e. when a placement is checked by yanking on it), during climbing (e.g. when the rope pulls against the cam due to rope drag), due to 'static' loads (e.g. sit rests, abseiling, lowering, etc.) or due to falls.

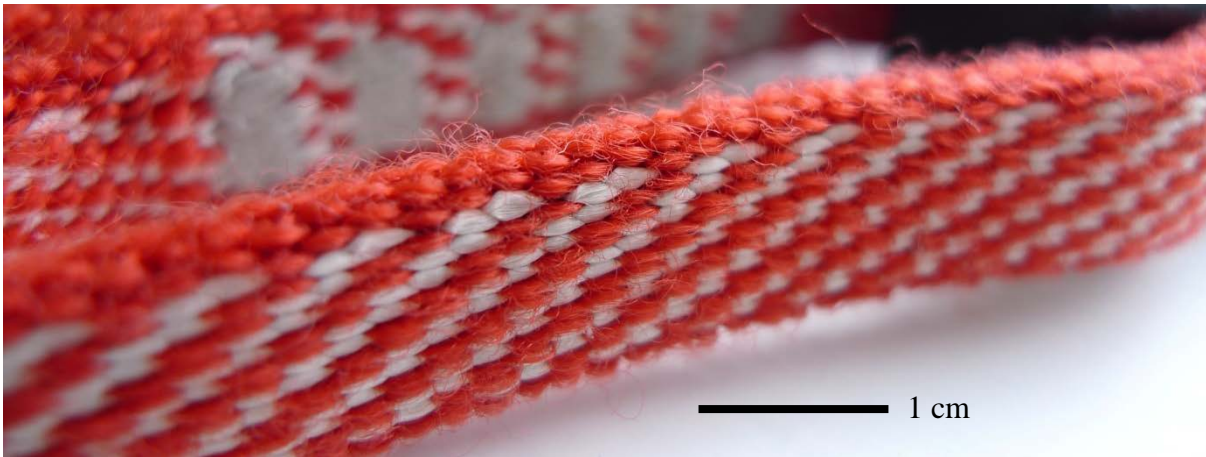
Figure 3: Red 0.5 sling

The slings on both cams show significant wear (Figures 3 and 5), with slightly more visible abrasion on the Red 0.5 cam. The plastics sheaths which partially cover the stem cables are in similar condition on each cam, showing numerous small nicks and scrapes and significant abrasion. The stem cables are in very similar condition with noticeable abrasion (Figures 2 and 6). The cam lobes on the Red 0.5 cam show very high wear, with significant rounding and loss of material (Figure 9). The lobes on the Yellow 1.0 show high wear, although slightly less severe than the Red 0.5.

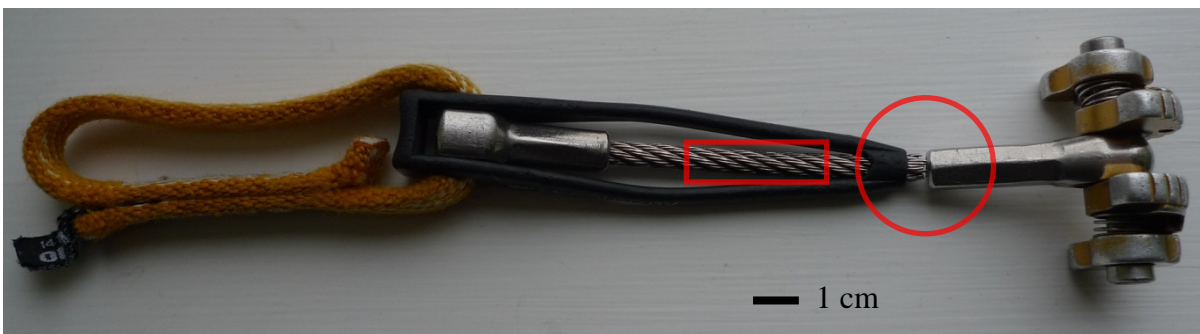
Figure 4: Yellow 1.0, location of failure circled, location of figure 6 marked by rectangle

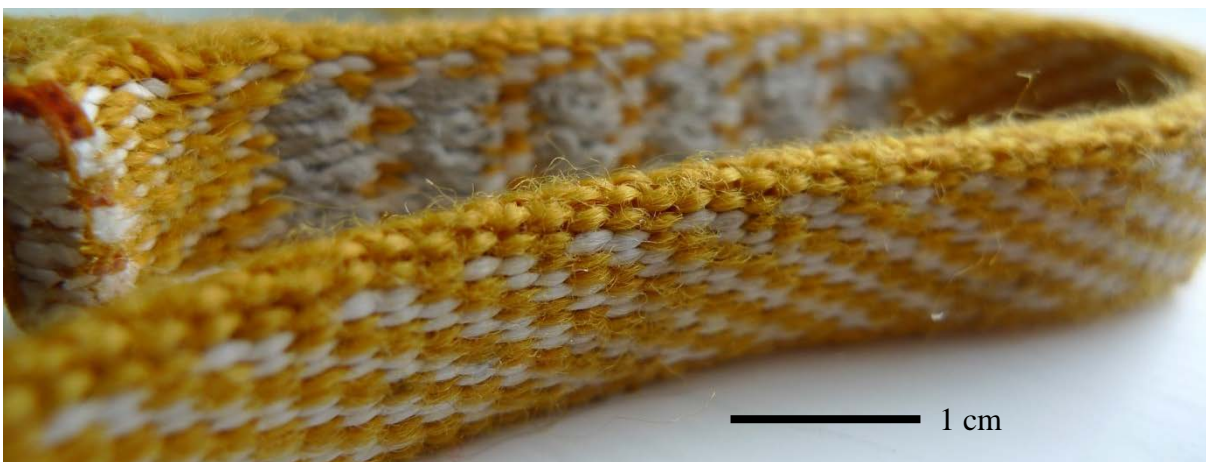
Figure 5: Yellow 1.0 sling

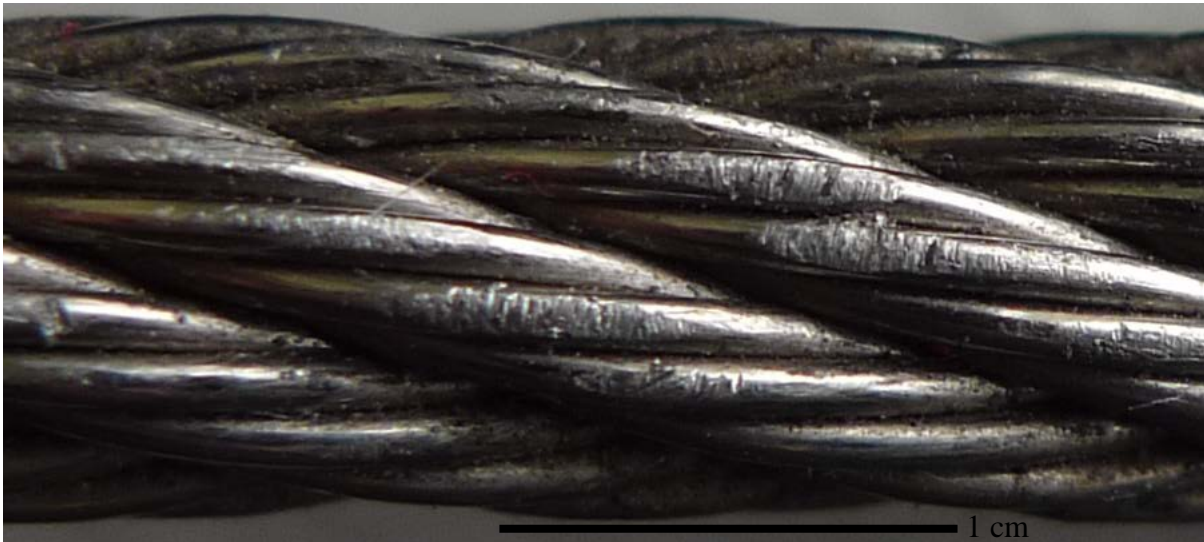
Figure 6: Yellow 1.0 cable abrasion

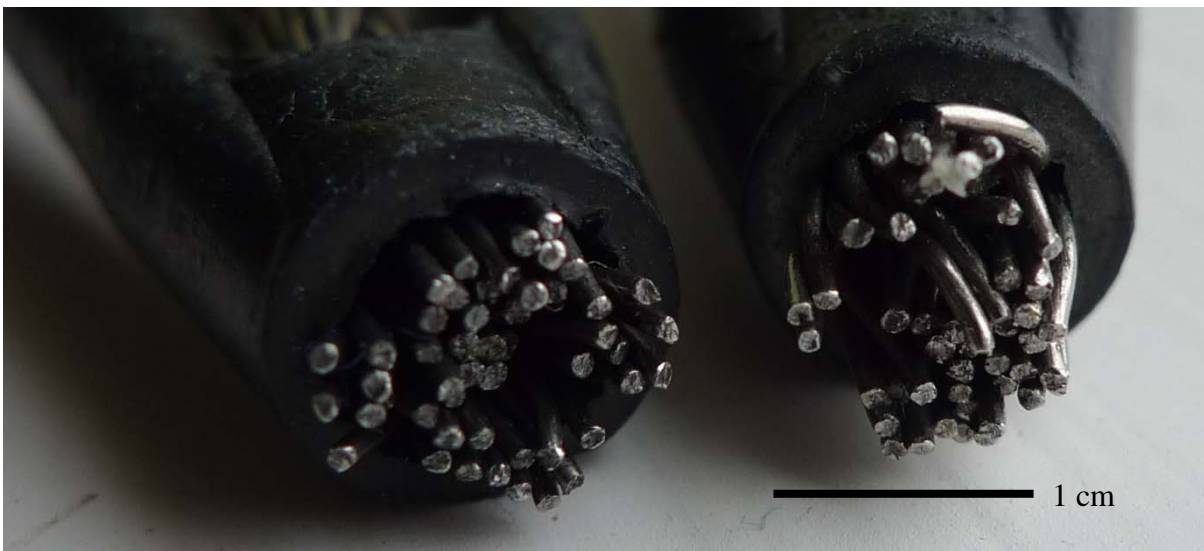
Figure 7: The cable side of the broken wires – looking towards the trigger side; Red 0.5 on left, Yellow 1.0 on right

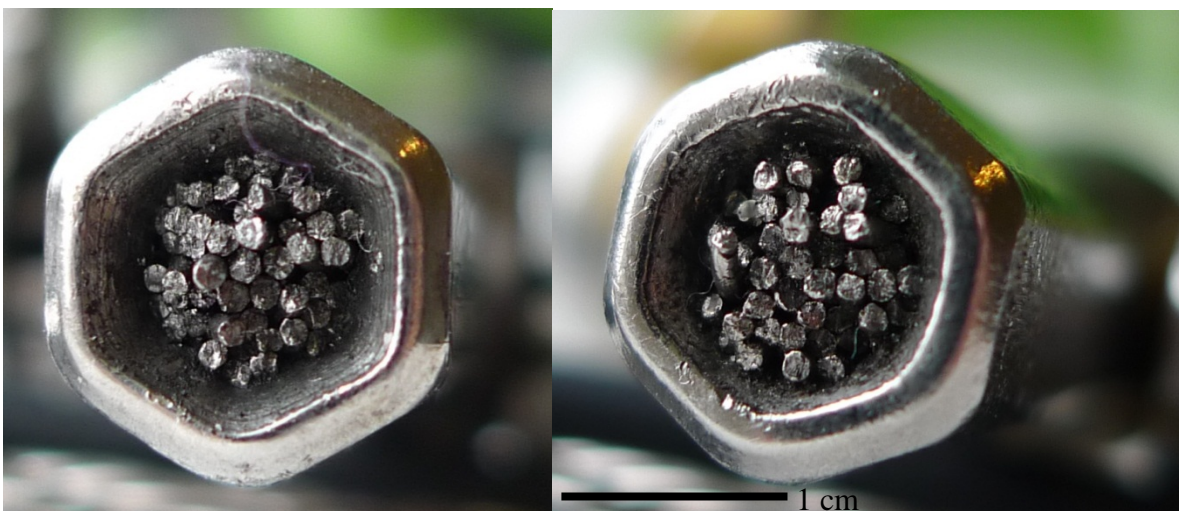
Figure 8: The solid stem side of the broken wires; Red 0.5 on left, Yellow 1.0 on right

In each cam, when the stem cable is bent, the part of the cable adjacent the solid stem is forced to bend around a very small radius formed in the outer edge of the solid stem. This will increase bending stress in the cable at this location and therefore accelerate fatigue in the cable.

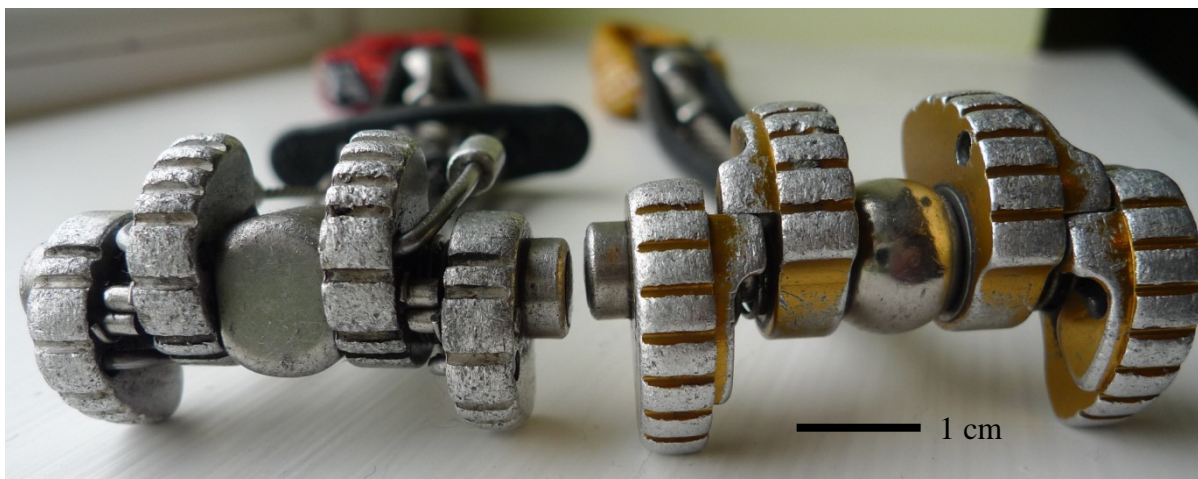
Figure 9: Left Red 0.5, and right Yellow 1.0 cam lobes
